Lake Ainsworth Coastal Management Program

Stage 2 – Vulnerabilities and Opportunities Study

18-009 LAKE AINSWORTH COASTAL MANAGEMENT PROGRAM
STAGE 2: VULNERABILITIES AND OPPORTUNITIES STUDY

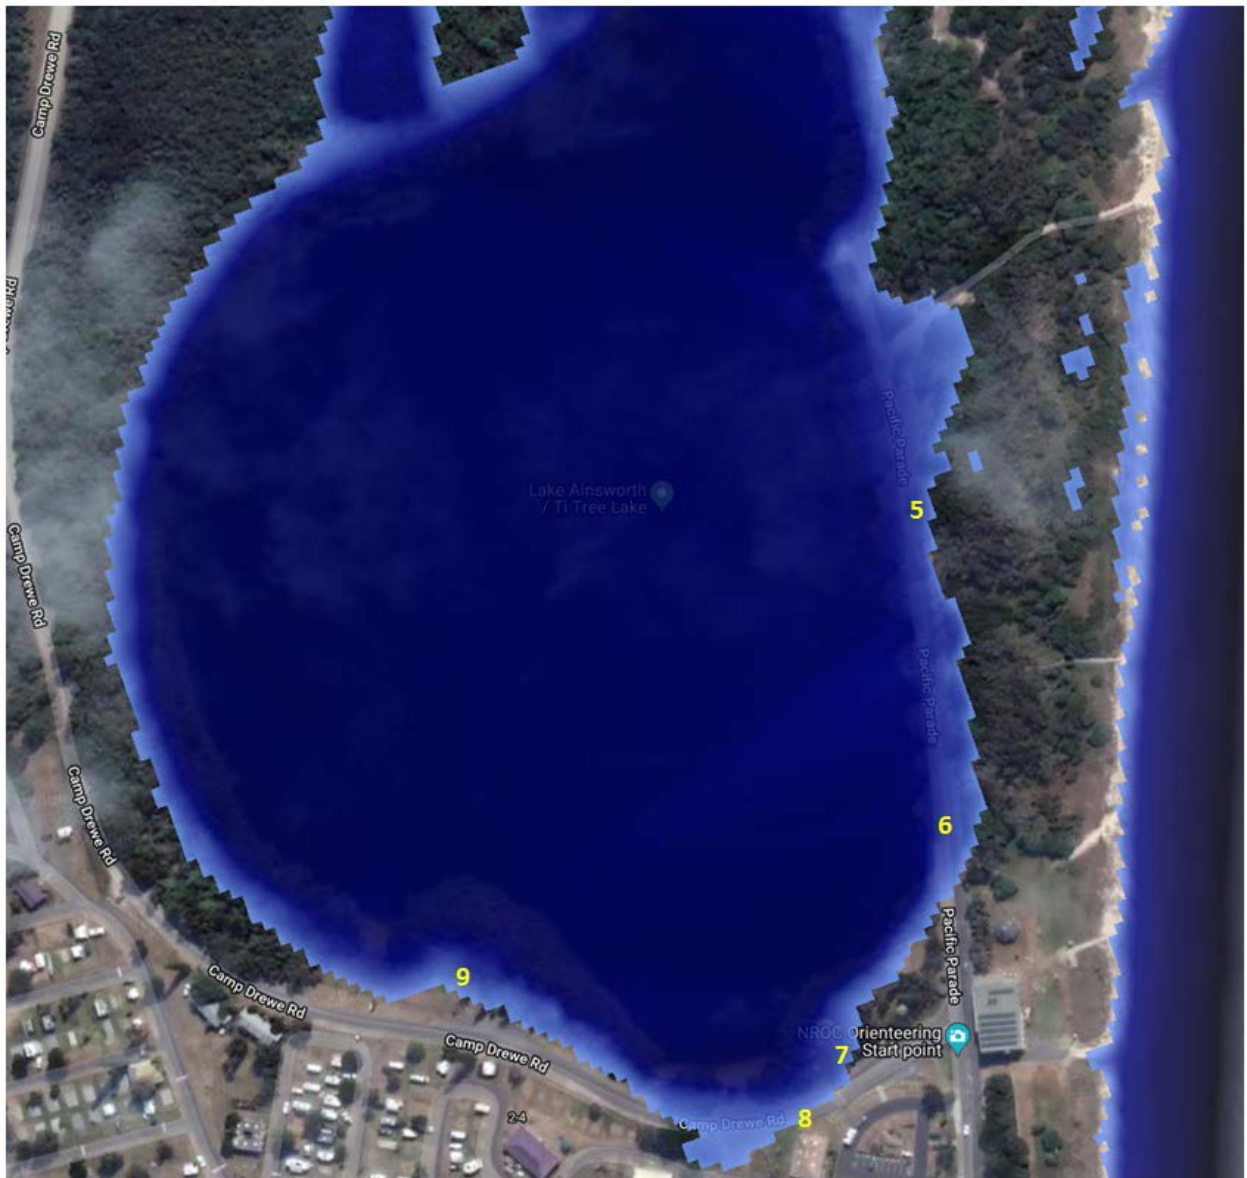
Figure 13: Infrastructure currently at or below the 2100 potential flood risk area (high emissions scenario), southern end of the lake (Source: Generated using Coastal Risk Australia Interactive Map Tool, March 2019).

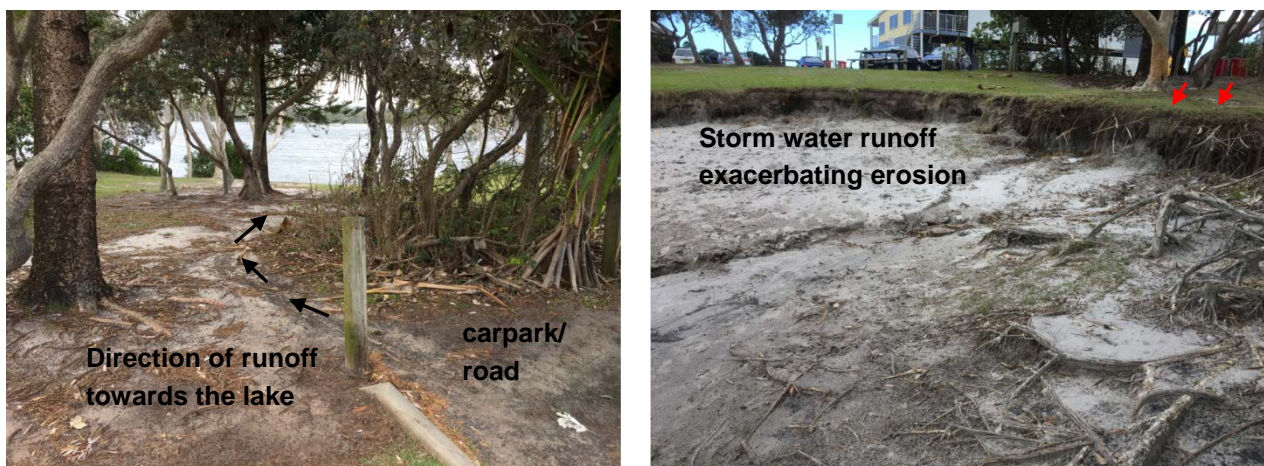
Plate 4: Left - Carpark areas in south-east corner opposite Lennox SLSC showing areas of scour due to stormwater runoff from hard surfaces; Right - Erosion Site 7, downslope of the carpark.

A number of factors were noted as contributing to bank erosion at Lake Ainsworth. Natural erosion processes are the key driving forces which are accelerated in many places by human impacts. Water level changes and wind driven wave action are primary natural causes of erosion at the lake but this is exacerbated by pedestrian access and stormwater runoff, particularly from the southern and eastern roads and parking areas. Much of the severe erosion observed at the lake occurred along the southern and eastern extents at heavily utilised access points, with little or no riparian vegetation and evidence of stormwater runoff scouring the banks (Plate 4). One of the most heavily trafficked access points in the south-eastern corner of the lake, is somewhat protected by mature Broad-leaved paperbark trees holding the banks together, although the trees have been severely undermined by erosion, with a high level of root exposure and many showing signs of poor health most likely as a result of excessive root exposure (Plate 5). Erosion issues are less prominent along the western shoreline, where riparian vegetation is largely intact, stormwater is not an issue and numbers of people accessing the foreshore is generally less.

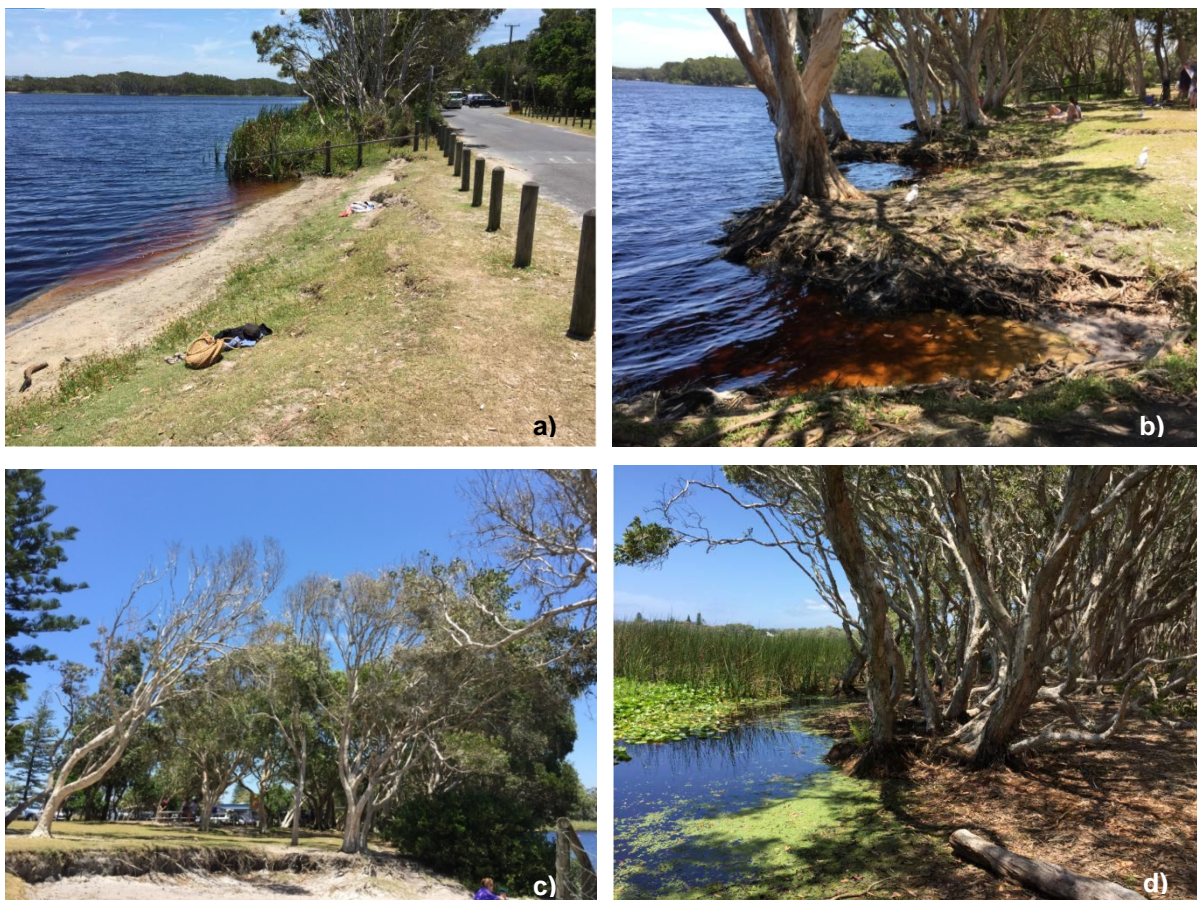
Plate 5: a) Priority 1 erosion at site 9, in close proximity to the eastern road; b) Priority 2 erosion at site 6 showing Broad-leaved paperbark trees severely undermined by erosion leading to root exposure; c) Priority 2 erosion at site 7 showing vertical erosion scarp at south-east corner access point. Broad-leaved paperbark trees showing signs of poor health due to root exposure; d) Priority 4 erosion at site 26 showing stable, vegetated banks and aquatic macrophytes.

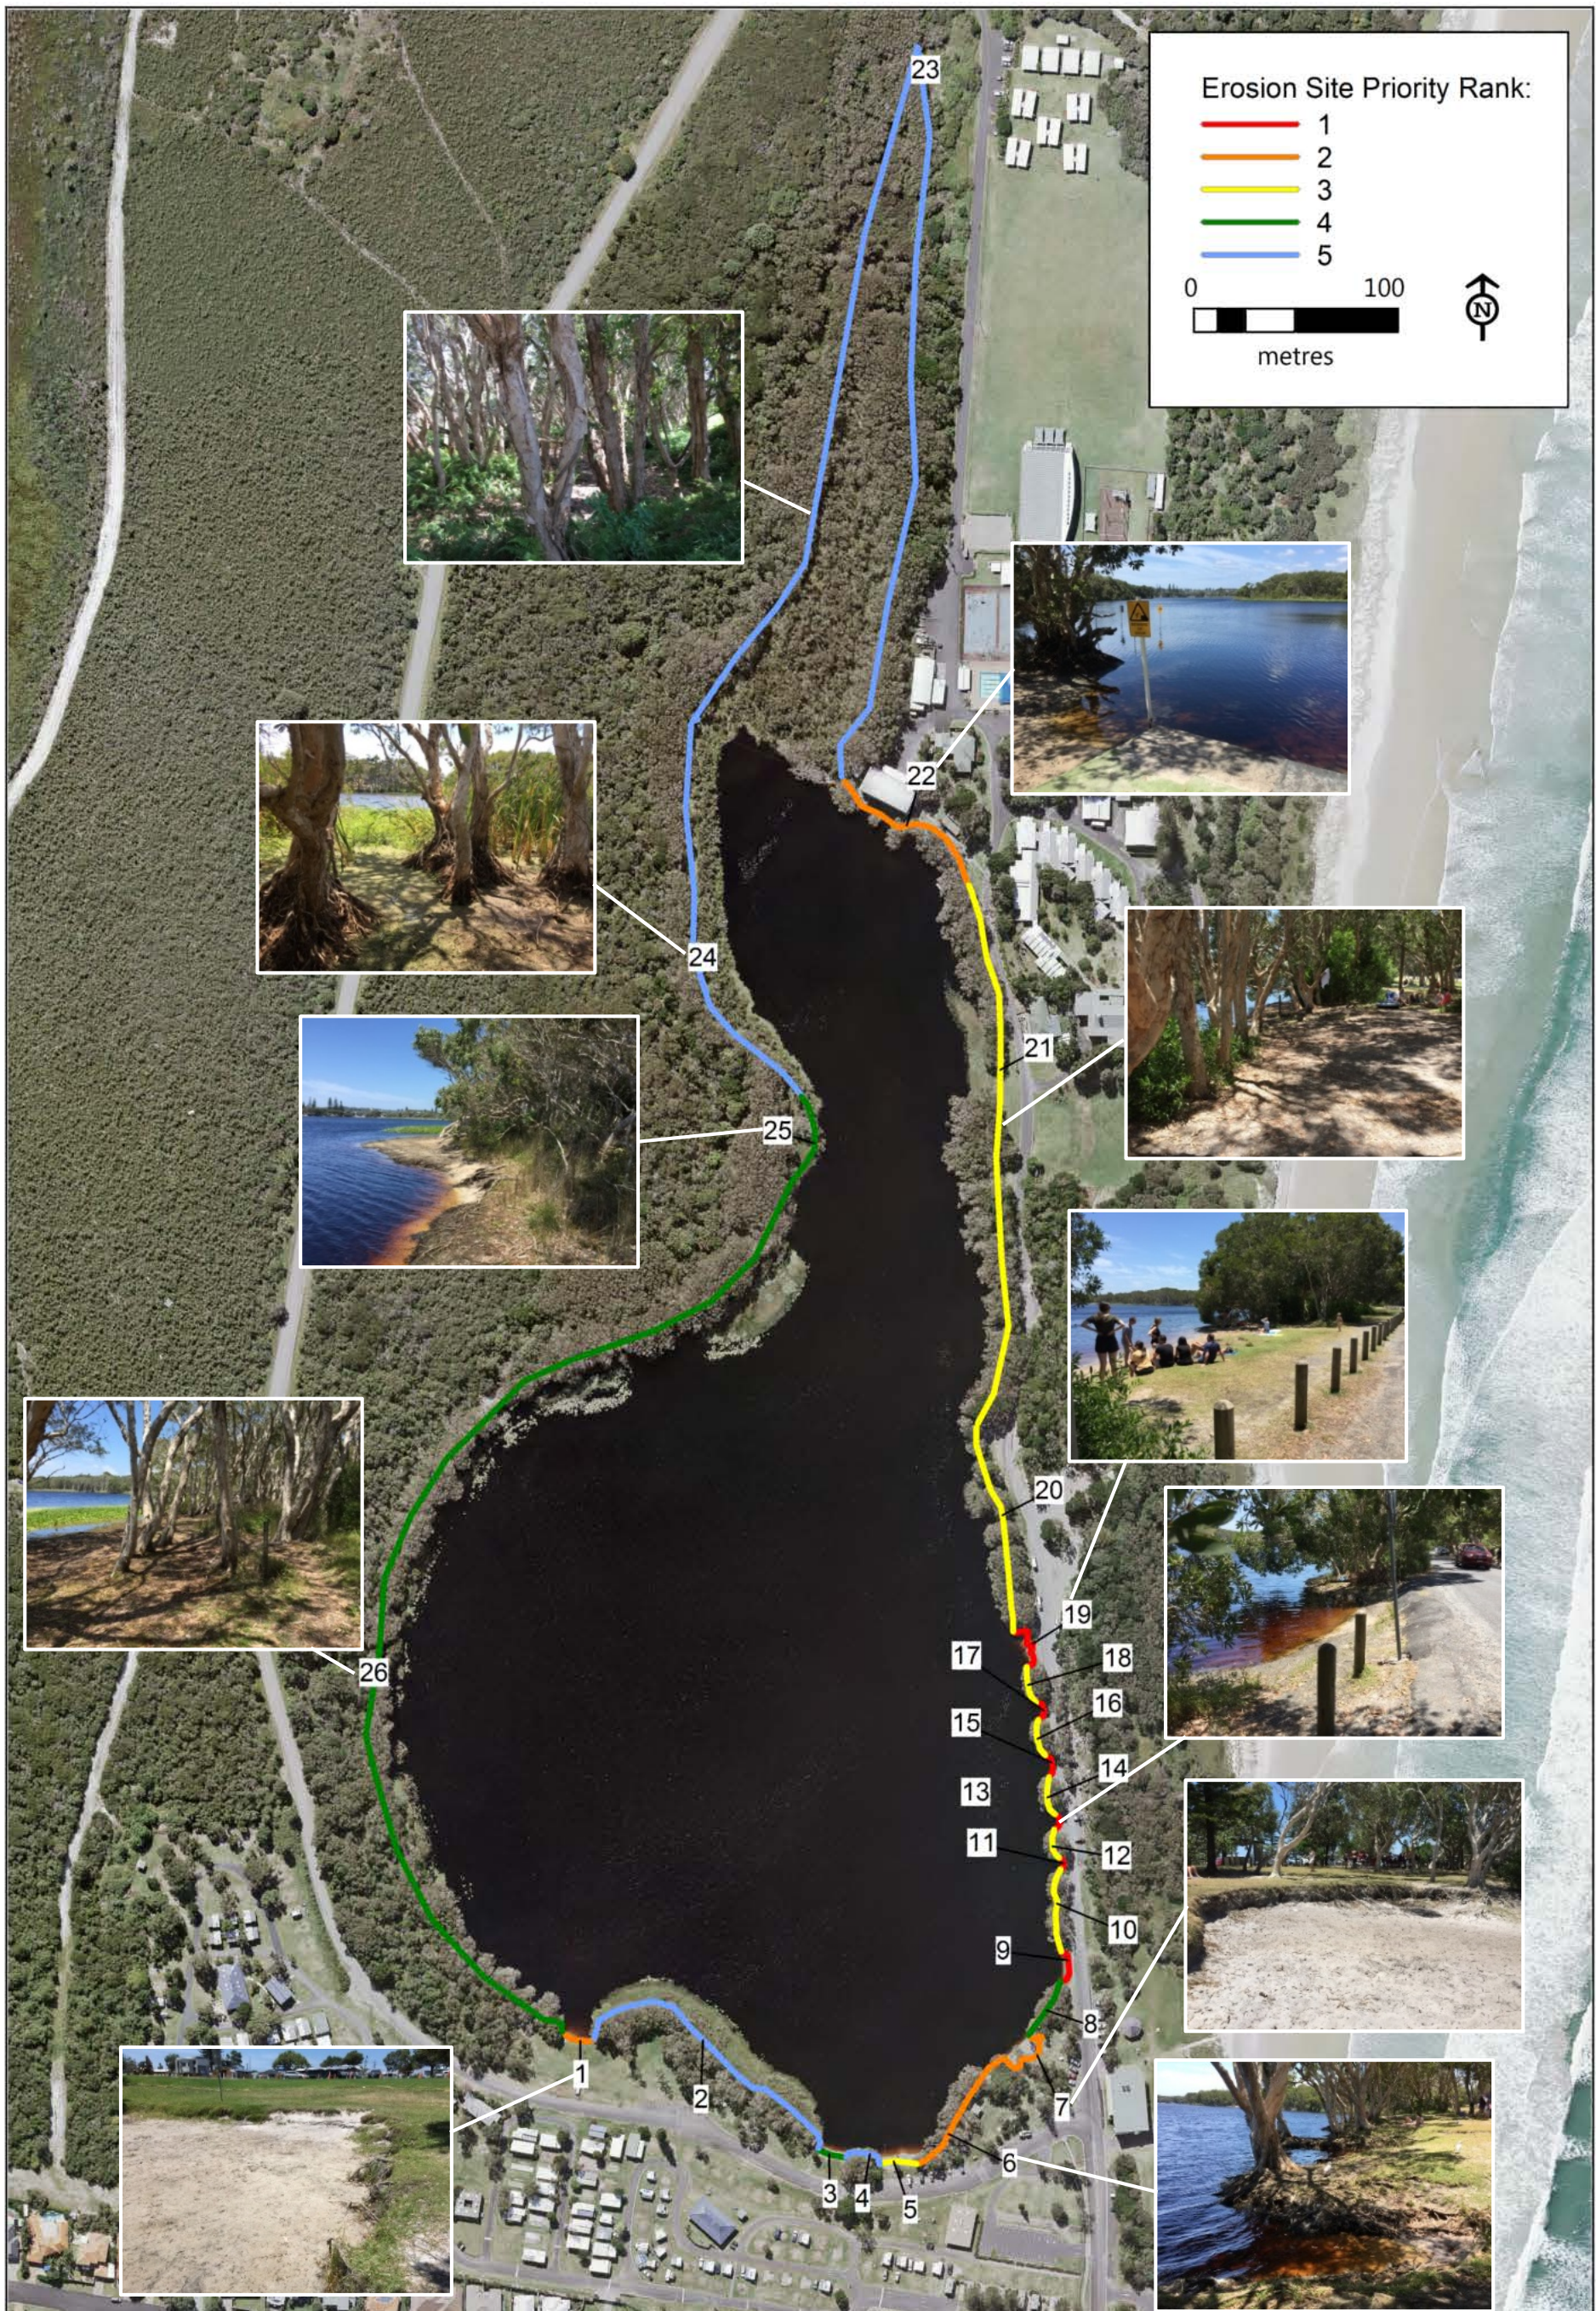
Figure 16: Location of priority erosion sites at Lake Ainsworth, assessed December 2018

Table 6 shows the resultant priority rank for all sites and their locations are mapped in Figure 16. The highest priority sites (Priority 1) comprised a series of small inlets all located along the eastern shoreline and constrained by the eastern road. These all displayed moderate erosion ratings and very high public safety risk due to proximity to the road (refer Section 6.6) and were within close proximity to built assets that could be impacted by continued erosion (the road, water mains etc.). Priority 2 sites were all located at access points with high frequency pedestrian use on the south-west foreshore, south-east corner and along the northern shoreline at the Sport and Recreation Centre. These displayed moderate to severe erosion with high safety risk and some within close proximity of built assets. Priority 3 sites were generally vegetated foreshores along the eastern and southern extents where access was restricted, safety risk was low and erosion was minor or controlled. These sites were all in close proximity to built assets, but the potential for these assets to be impacted was reduced due to the minor erosion observed. Priority 4 and 5 sites had minor, stable or controlled erosion, low or medium safety risk and no built assets under immediate threat from erosion. These sites were located along the relatively undisturbed northern arm and western foreshores and also vegetated foreshores along the south and south-east foreshores.

Erosion Site Priority Ranking	Site	Erosion Rating	Foreshore Access Safety Risk	Built assets within 5m
1	9	Moderate	Very High	Yes
1	11	Moderate	Very High	Yes
1	13	Moderate	Very High	Yes
1	15	Moderate	Very High	Yes
1	17	Moderate	Very High	Yes
1	19	Moderate	Very High	Yes
2	6	Moderate	High	Yes
2	22	Moderate	High	Yes
2	1	Severe	High	No
2	7	Severe	High	No
3	10	Minor	Low	Yes
3	12	Minor	Low	Yes
3	14	Minor	Low	Yes
3	16	Minor	Low	Yes
3	18	Minor	Low	Yes
3	20	Minor	Low	Yes
3	21	Minor	Low	Yes
3	5	Controlled	Medium	Yes
4	26	Stable	Medium	No
4	8	Minor	Low	No
4	25	Minor	Low	No
4	3	Controlled	Medium	No
5	2	Stable	Low	No
5	4	Stable	Low	No
5	23	Stable	Low	No
5	24	Stable	Low	No

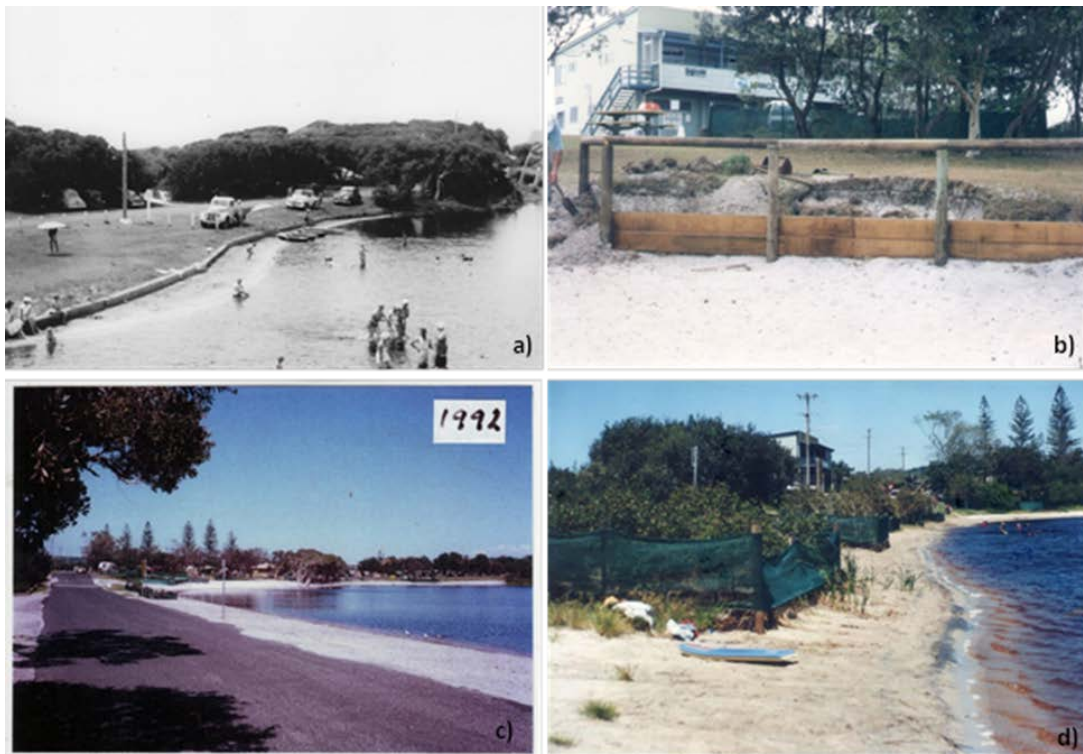
Plate 6: a) Log revetment in 1953 along eastern shoreline; b) timber retaining wall installed in 2000; c) eastern shoreline following dredging and beach nourishment 1992; d) Revegetation and fencing of eastern shoreline early to mid-1990's. (Source: Images courtesy of the Lennox Head Heritage Committee)

- Retaining walls placed along the shoreline including: large square-cut timber logs shown in Plate 6 (a) from 1953 along the eastern foreshore (some are still present and visible today when water levels are low); and a timber retaining wall installed in 2000 which is no longer at this location (Plate 6, b).
- Dredging of sand from the eastern side of the lake to nourish beaches along the lake's foreshore in the early 1990's (Plate 6, c). Some areas were turfed to stabilise the sand and control erosion.
- Riparian plantings and fencing in mid-90's, which are still present and have been shown to be effective in controlling erosion (Plate 6, d).

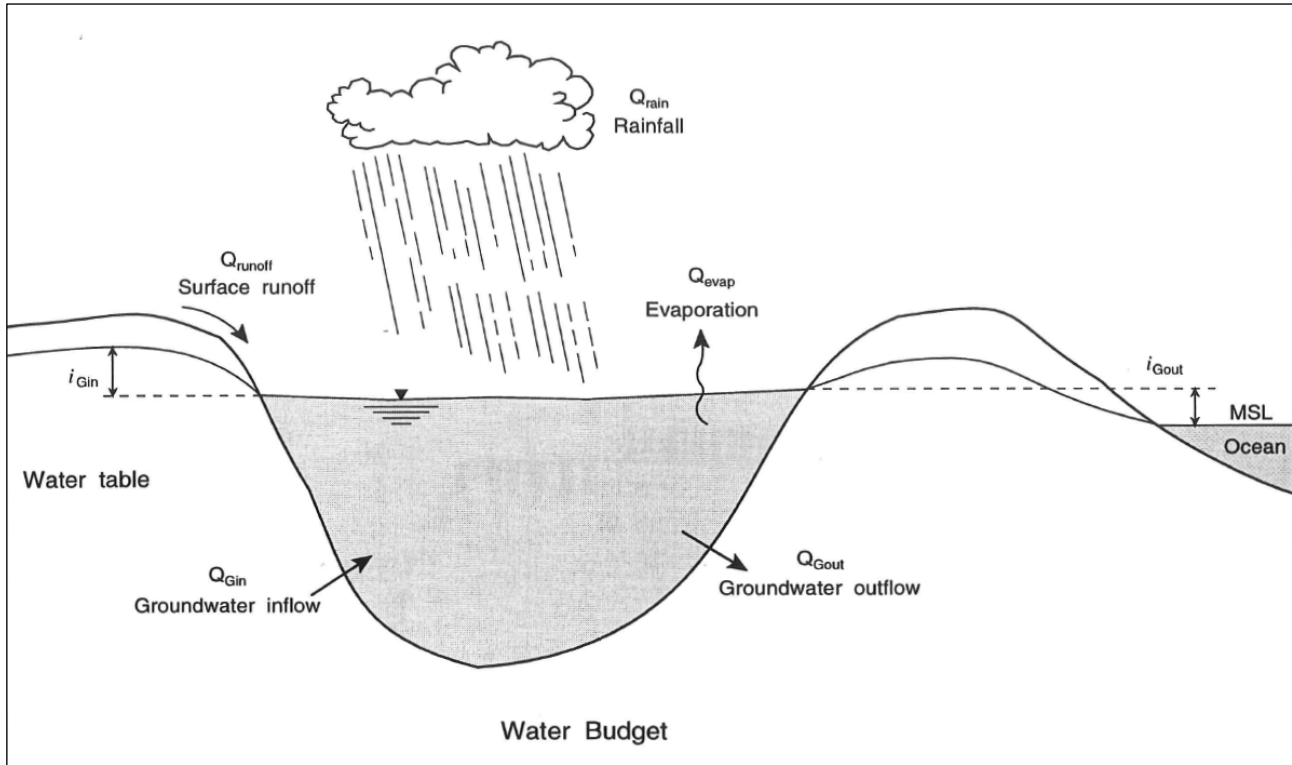
Figure 18: Water Budget schematic diagram (Source: AWACS, 1996)

A detailed assessment of the lake's water balance was completed as part of the 1996 Processes Study (AWACS, 1996). The lake water volume and water level are determined by a balance between inflows to the lake (direct rainfall, surface runoff and groundwater flows) and outflows (evaporation and groundwater discharge eastward through the dunes to the ocean). These elements are shown in Figure 18 below.

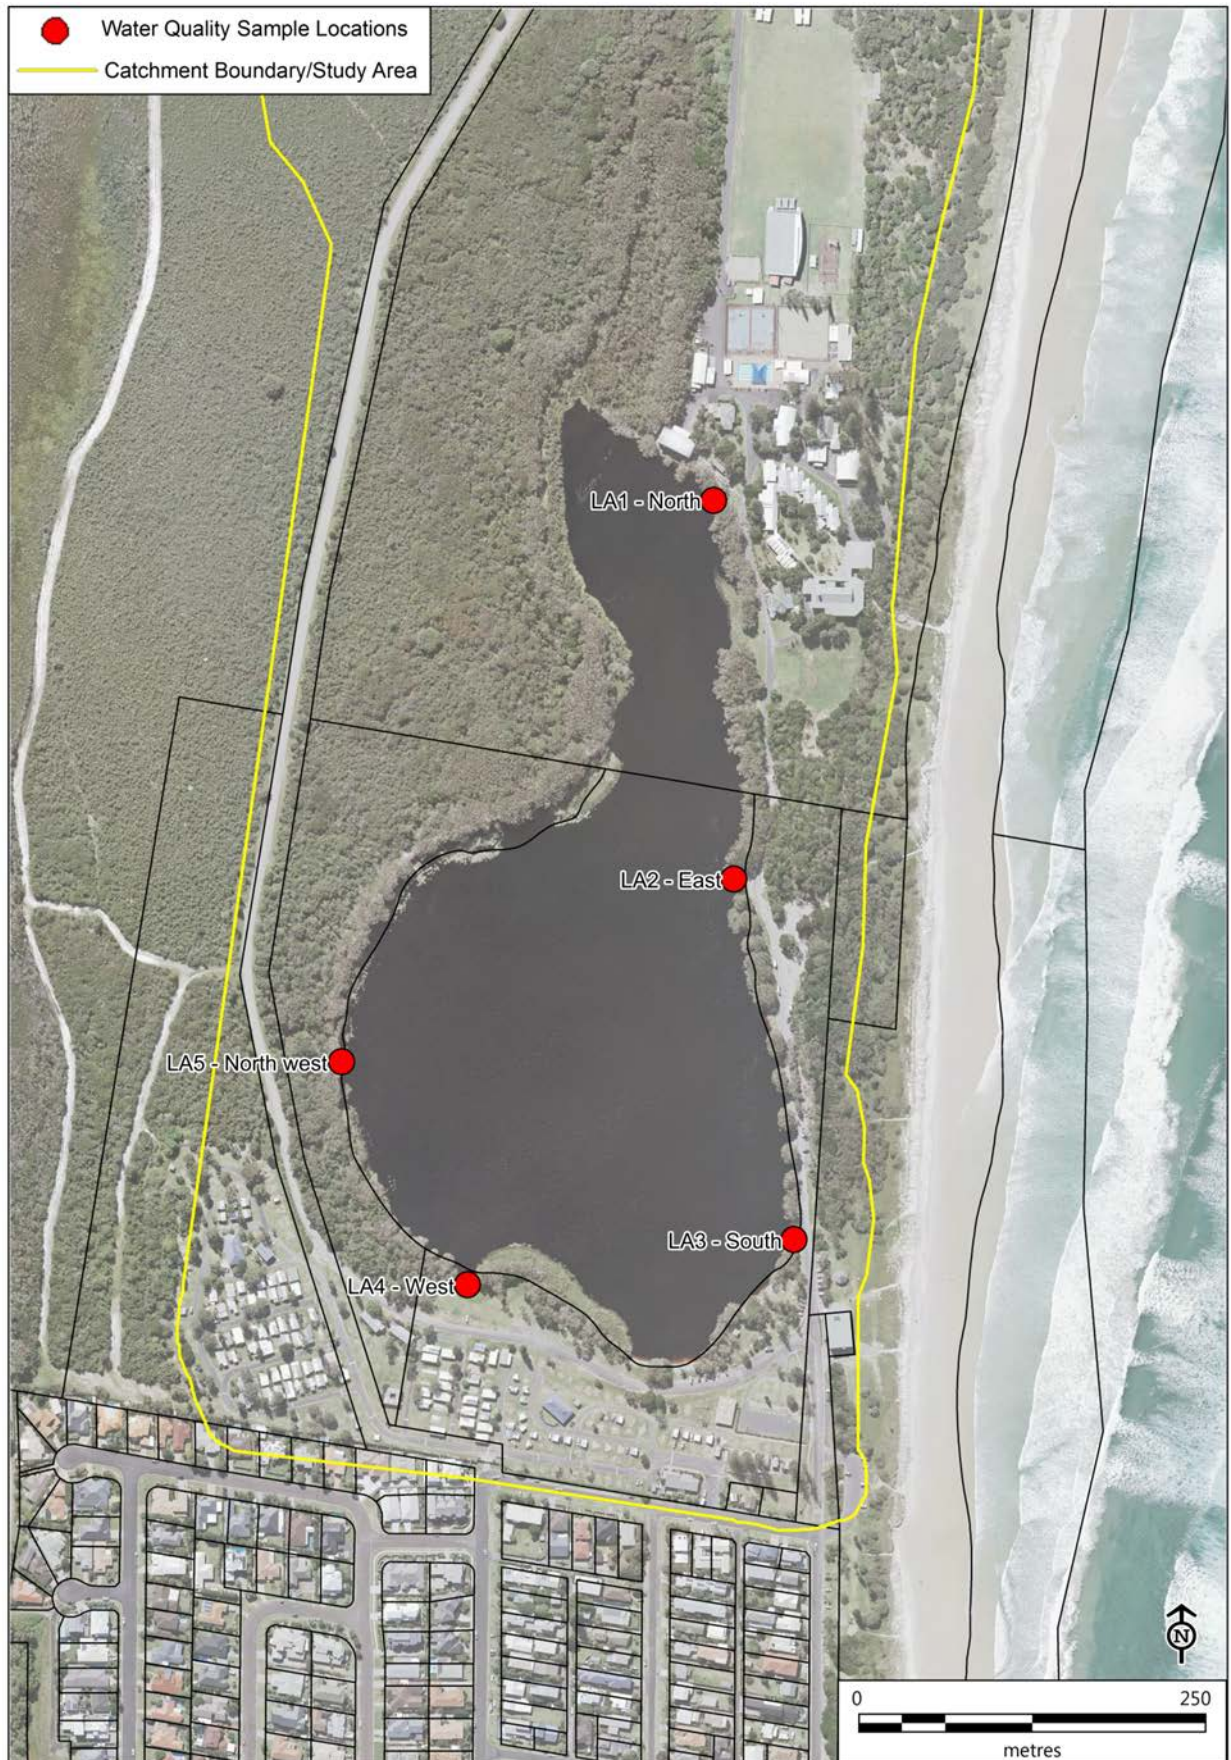
Figure 23: Lake Ainsworth water quality sampling sites from Dec 2015 – 2018

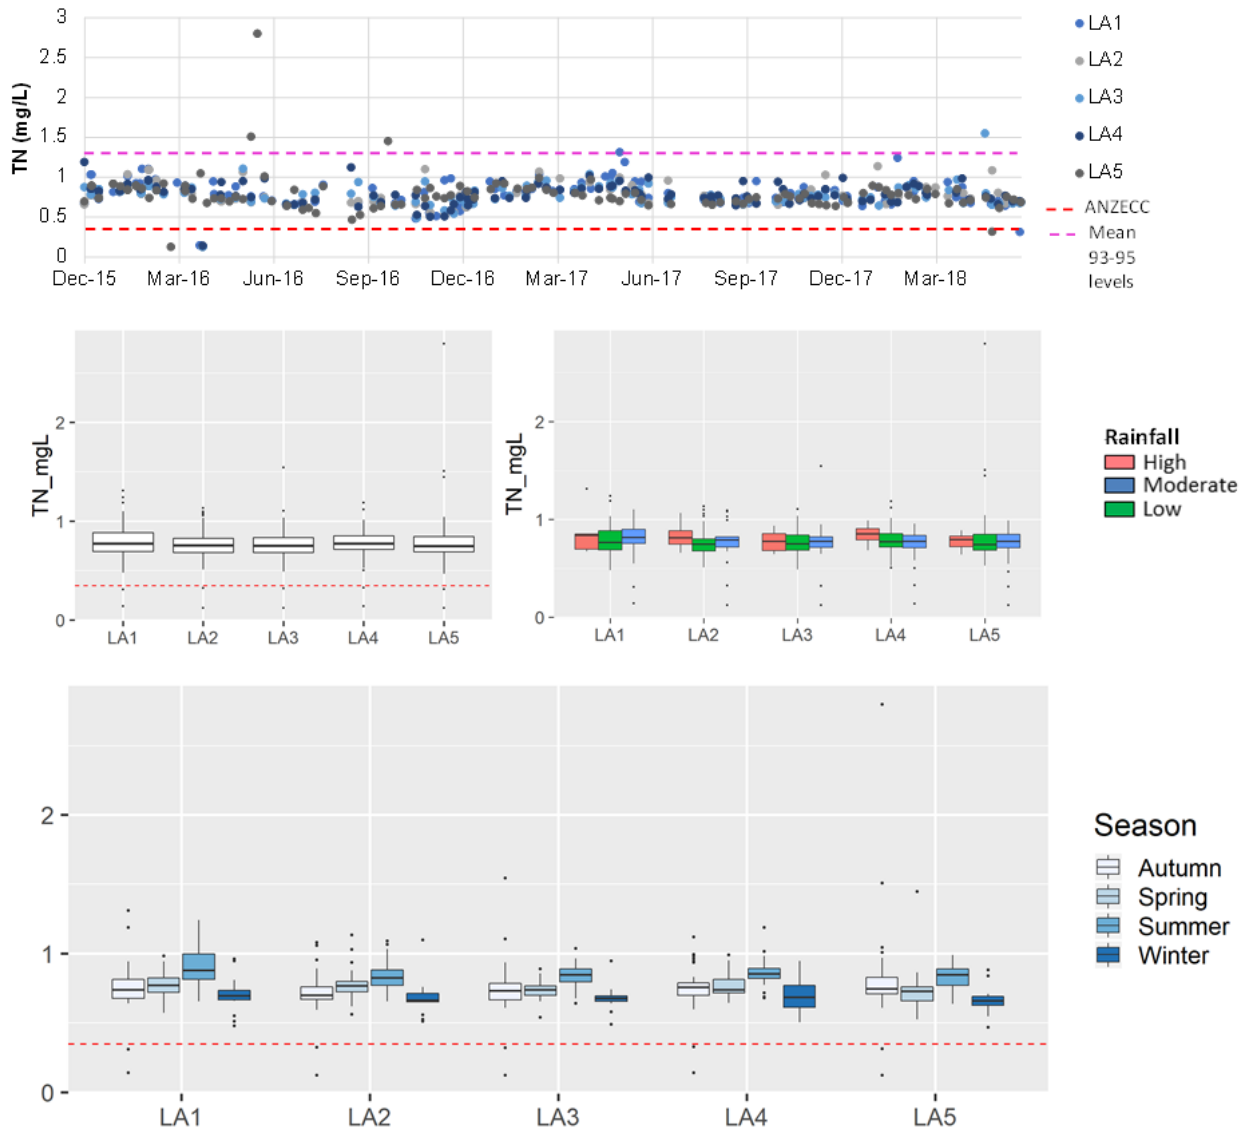
Figure 31: Lake Ainsworth total nitrogen (TN) Dec 2015-June 2018. Top - temporal variation; Middle left - Box plot showing range of all data at each site; Middle right - Spatial variation during low, moderate and high rainfall conditions; Bottom - Seasonal variation.
