Nambucca Coastline and Estuaries Coastal Management Program

Stage 2: Vulnerabilities and Opportunities Study

18-019 – NAMBUCCA COASTLINE AND ESTUARIES CMP – STAGE 2 VULNERABILITIES AND OPPORTUNITIES

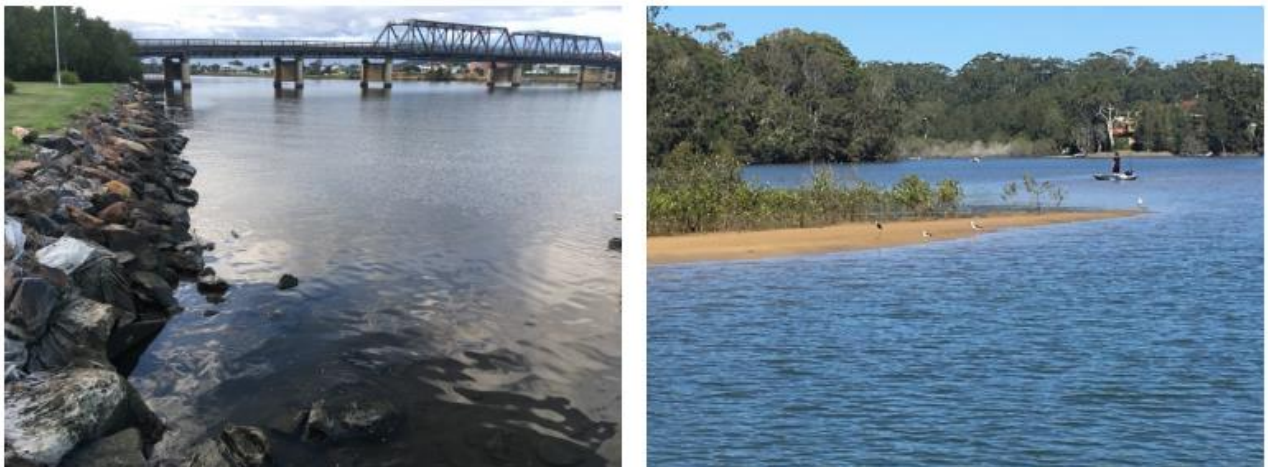
Plate 1: Bank condition in the Nambucca River Estuary, April 2019

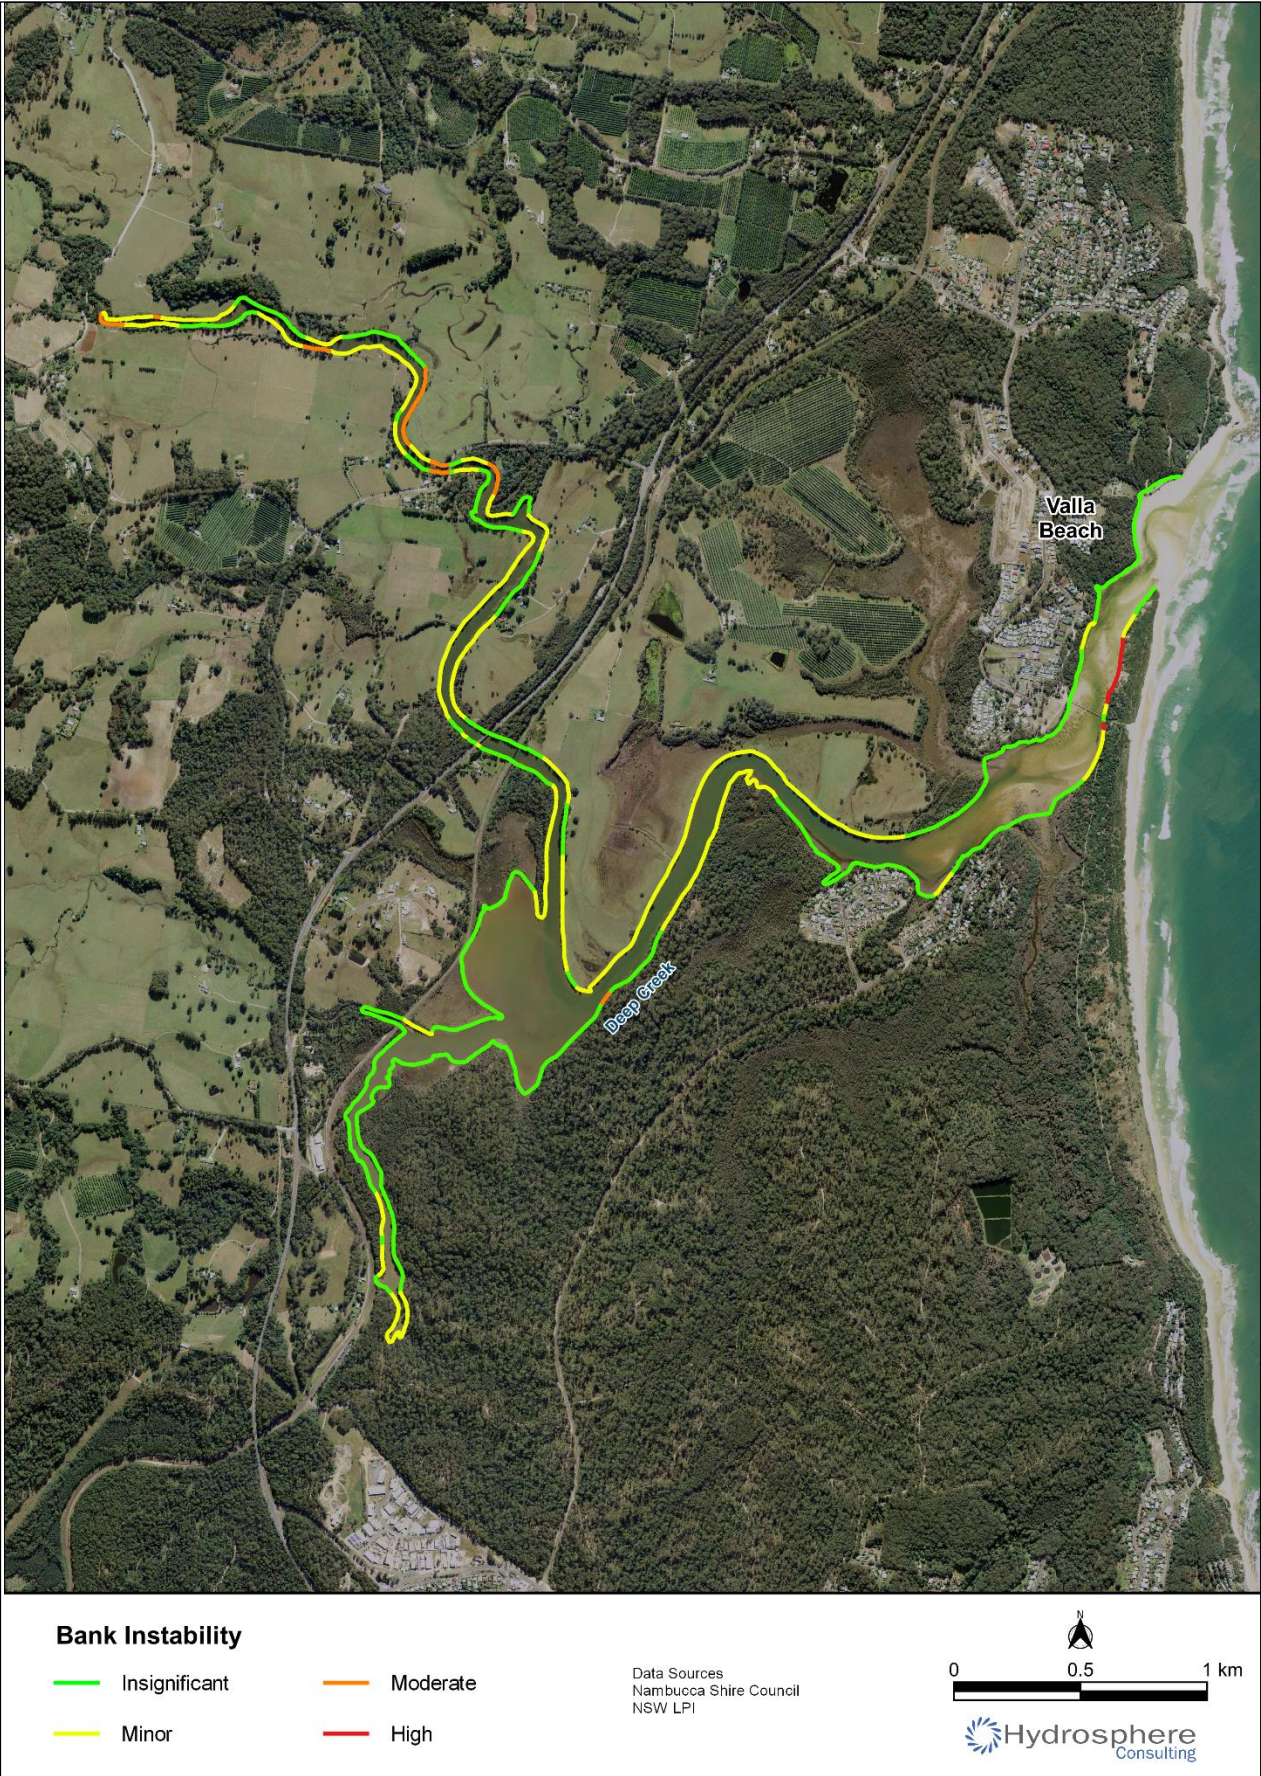
Figure 5: Bank instability – Deep Creek estuary

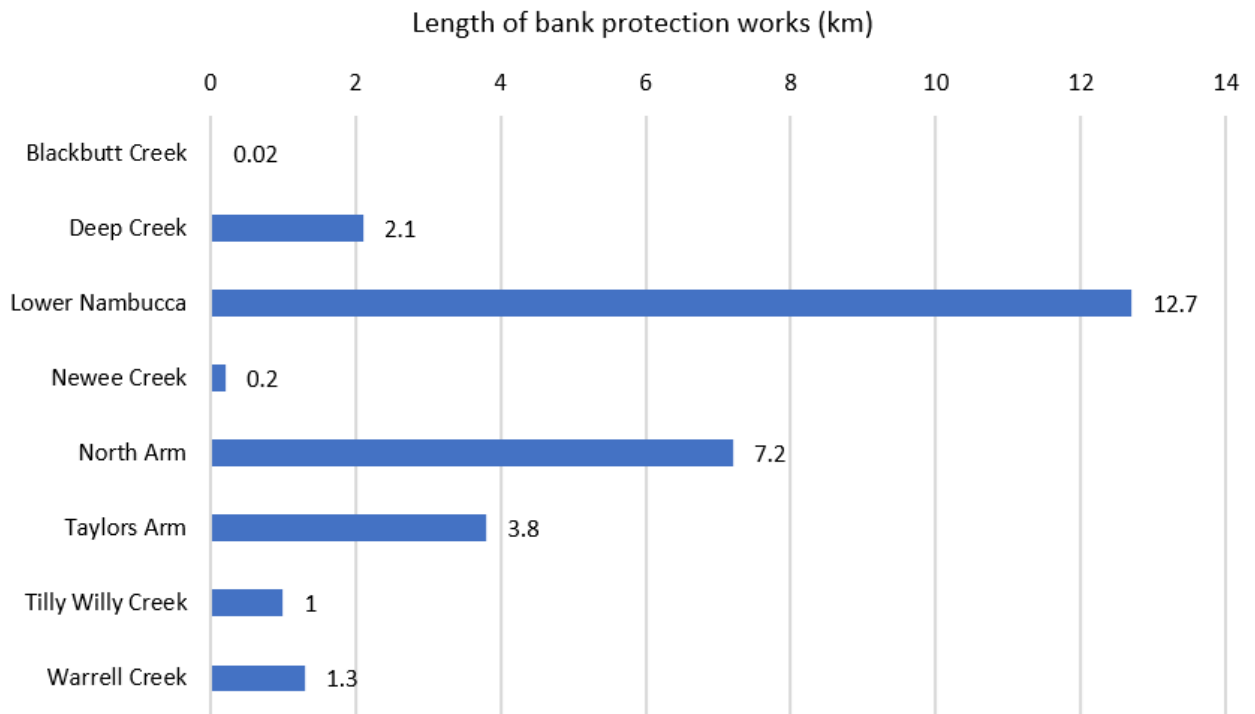
In total, approximately 30 km of bank protection works were identified within the 210 km of estuary banks surveyed in this study. This was almost twice the amount recorded during the GECO (2005) survey and indicates a significant increase in bank protection works being undertaken in the last 14 years. Table 2 provides a summary of the extent and effectiveness of bank protection methods observed in the study area. Figure 6 shows the relative length of bank protection works within each system, Figure 7 shows the overall effectiveness of bank protection measures observed in each system and Figure 8 provides a breakdown of the different bank protection methods and materials used in each system.

Figure 6: Length of bank protection works along each system

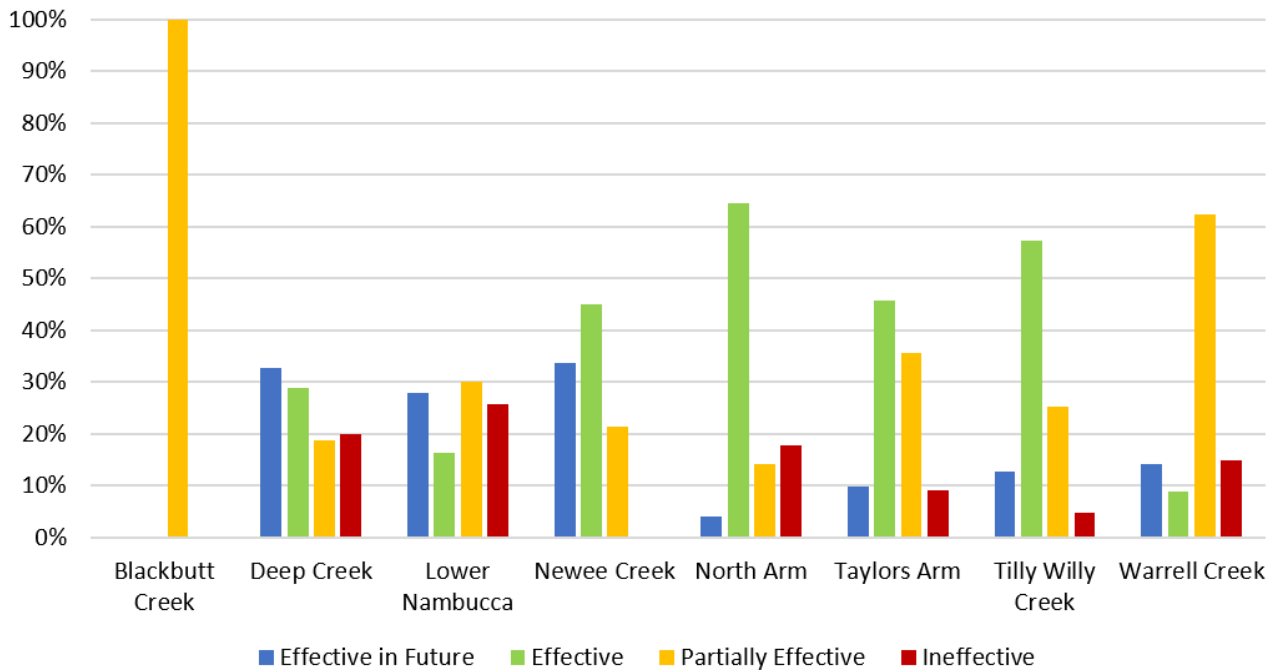
Overall, considering all systems assessed, 23% of the bank protection works were considered to be ineffective. Building rubble, tyres and timber protection works were common examples of the largely ineffective bank erosion control measures observed.

Figure 7: Effectiveness of bank protection measures observed in each system

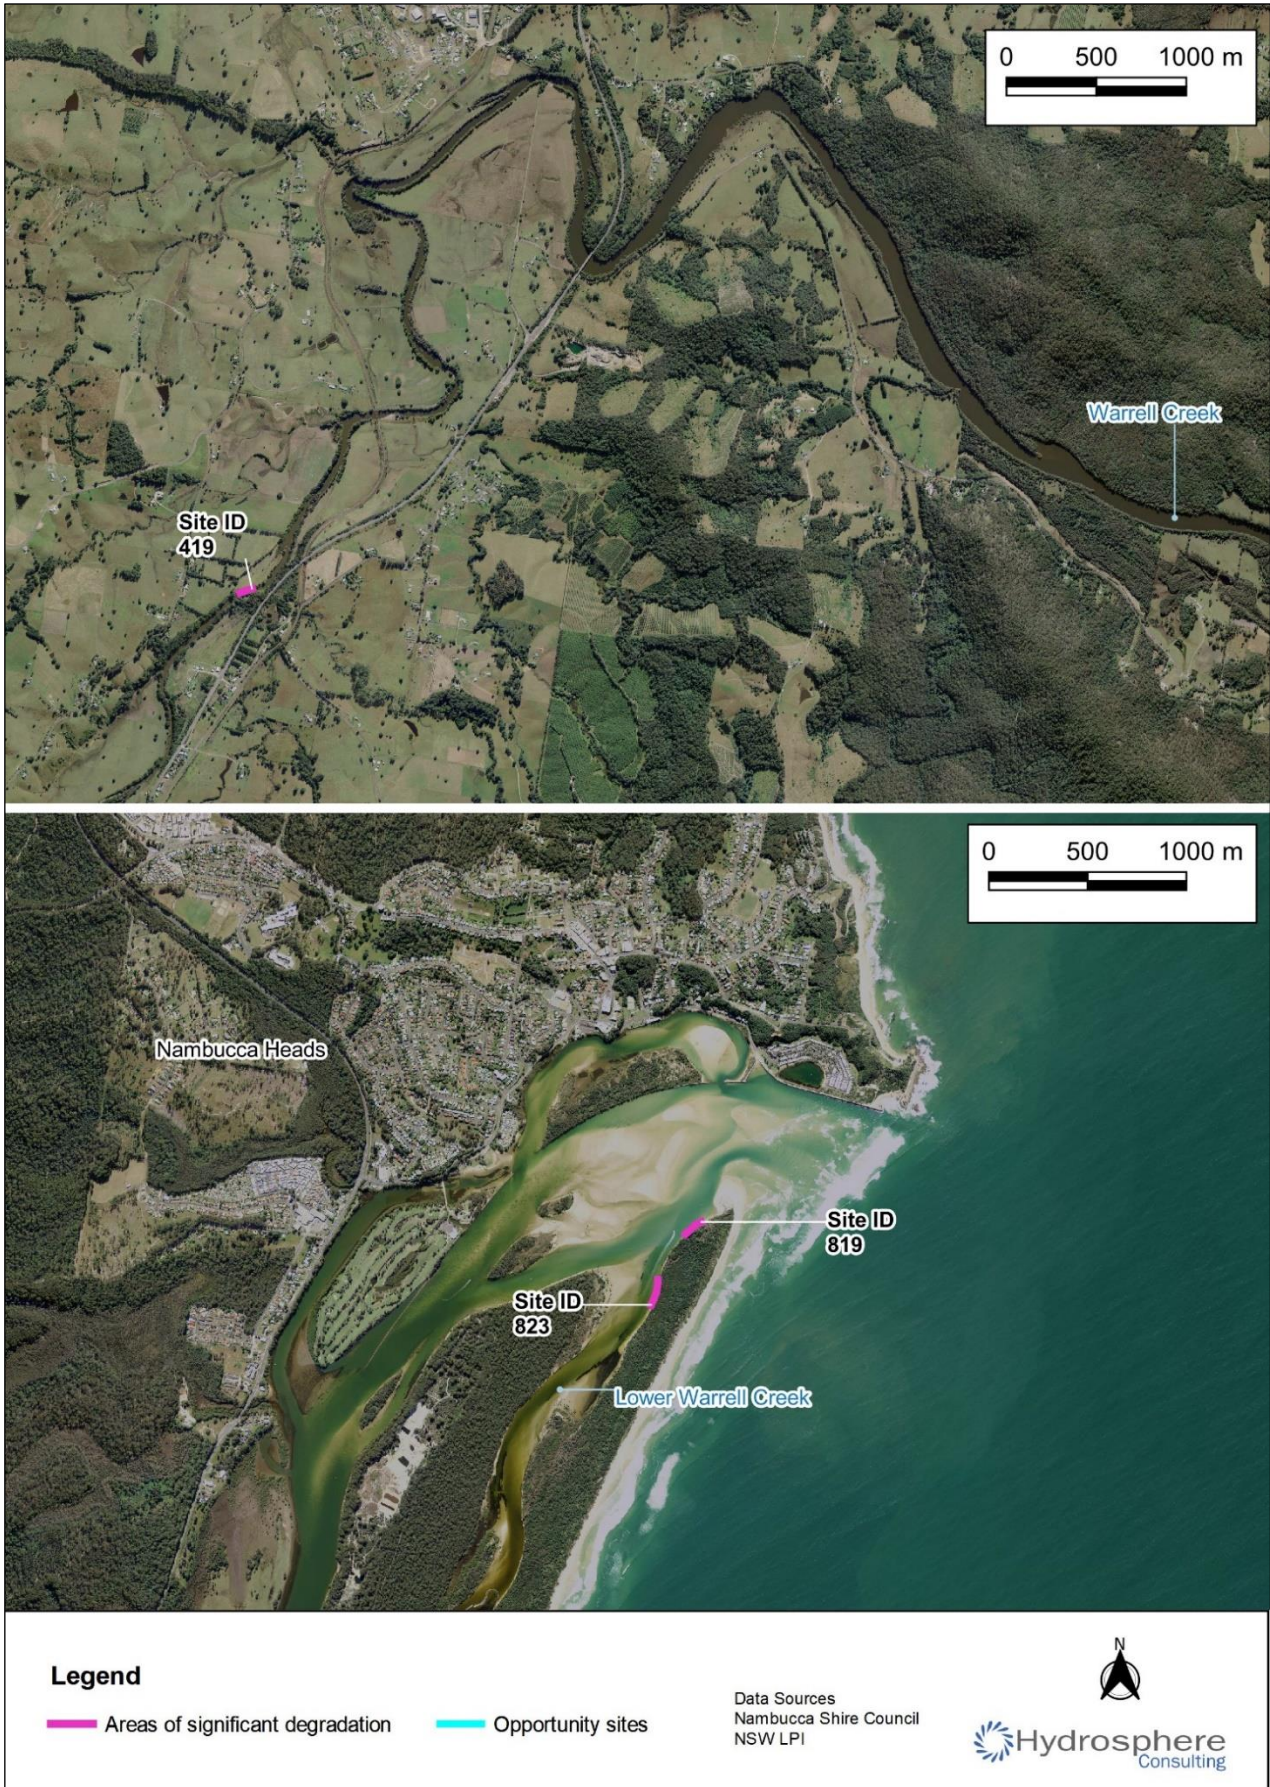
Figure 11: Recommended bank management sites on upper (top) and lower (bottom) Warrell Creek

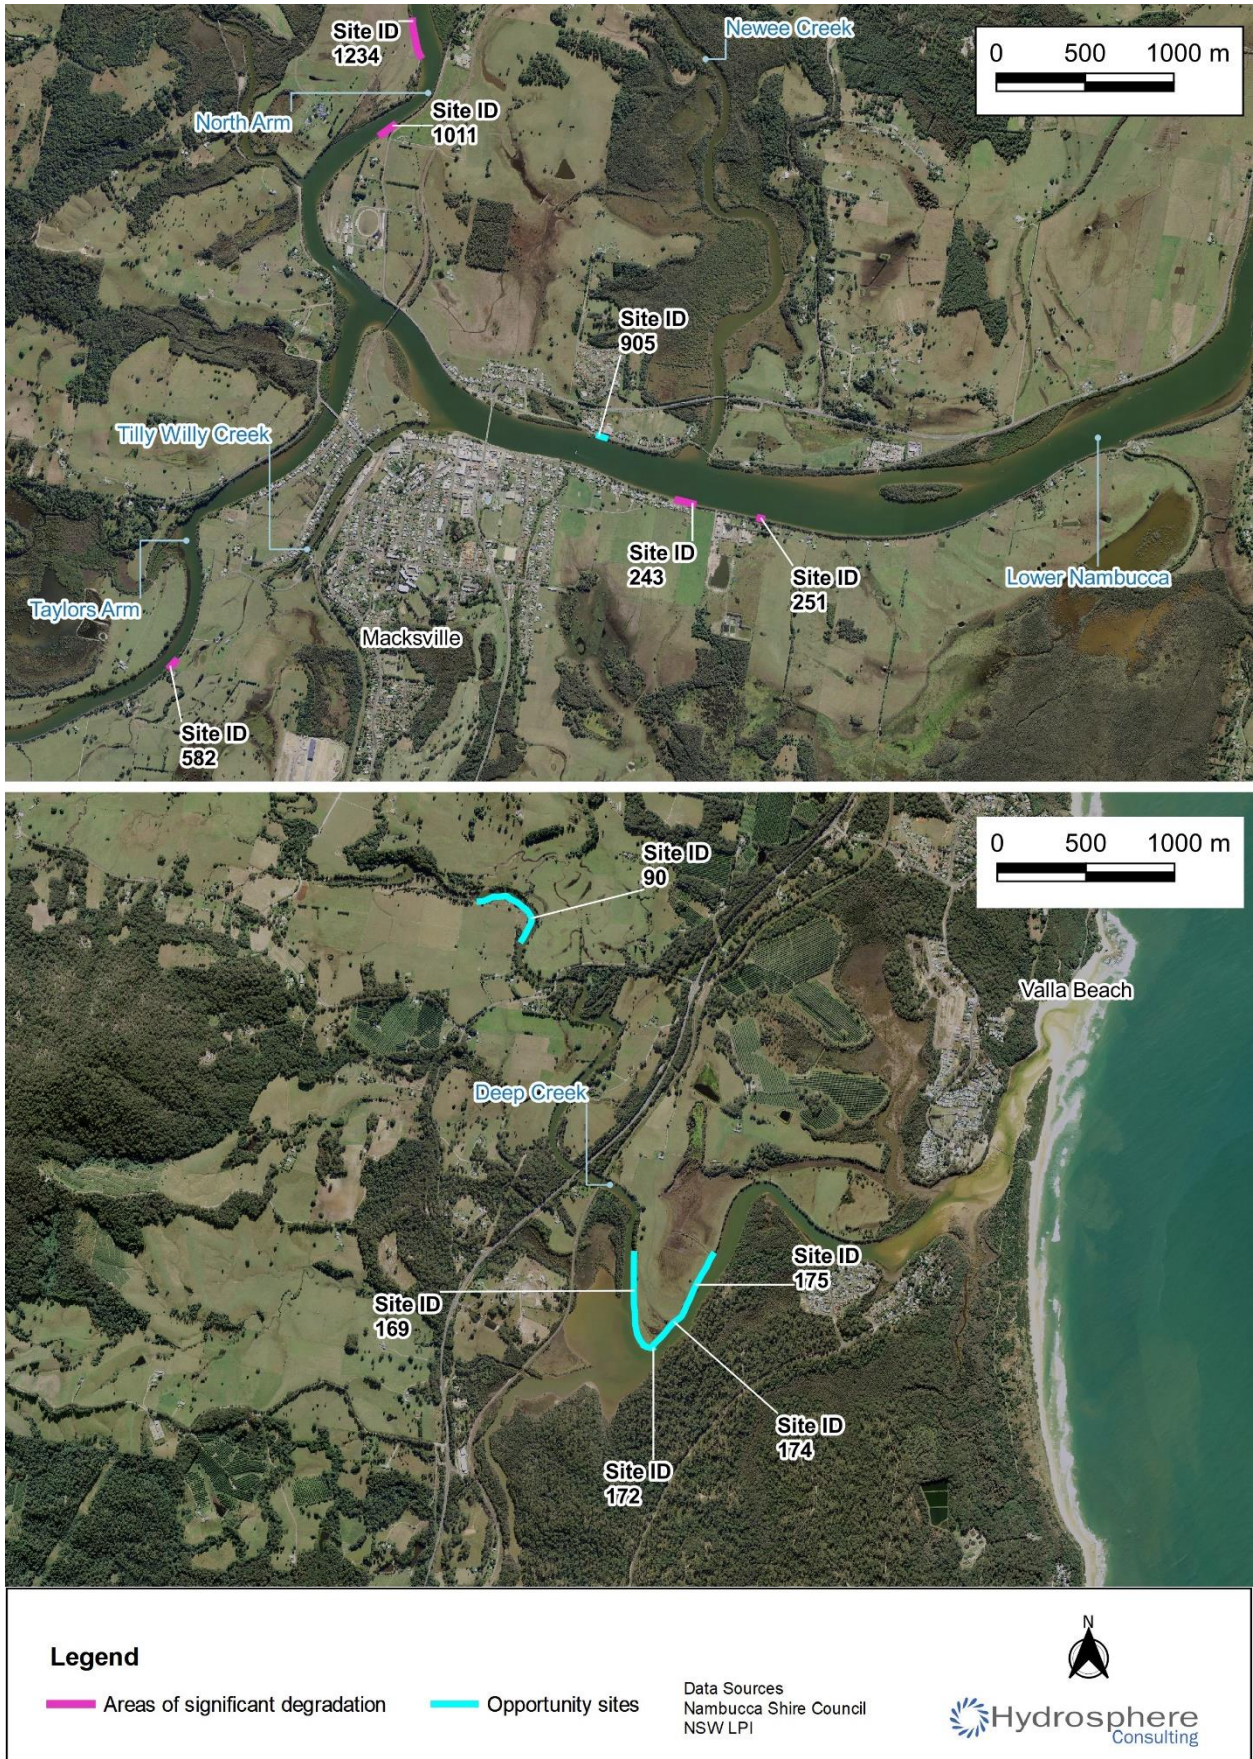
Figure 12: Recommended bank management sites on the Nambucca River (top) and Deep Creek (bottom)

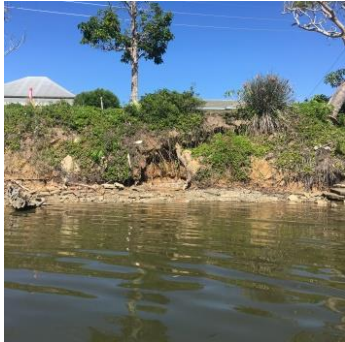
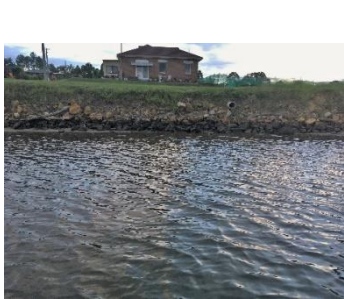
Location	Opportunity	Total Combined Length	Identified Causes of Instability	Site IDs	Representative Photos	
					Priority site	Opportunity site
Nambucca River	<u>Priority sites</u> Sites with high instability and riparian vegetation in poor condition.	90 m	Public access and structure causing erosion	243 and 251

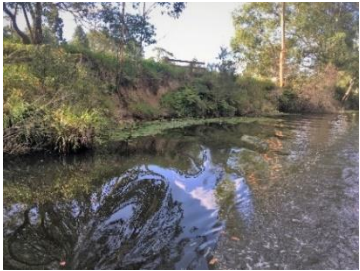
<u>Opportunity site</u> Grassy section of bank devoid of riparian vegetation in an urban area would benefit from revegetation.	36 m	Boat/ wind waves and poor riparian vegetation.	905		
Warrell Creek	<u>Priority sites</u> Sites with high instability and riparian vegetation in poor condition.	309 m	Natural meander	419, 823, 819

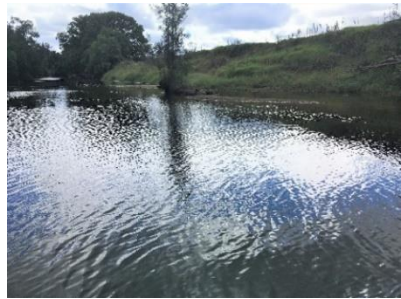
Site ID	Length (m)	Riparian Vegetation Condition	Bank Instability	Causes of Instability	Justification	Photo
1119	188	Poor	High	Natural meander, Cattle access	Significant degradation

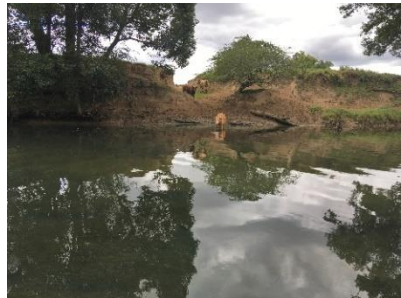
1117	39	Poor	High	Cattle Access	Significant degradation

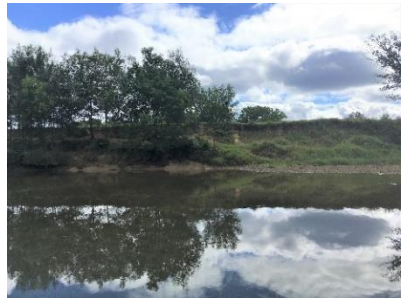
1115	493	Poor	High	Natural meander, Cattle access	Significant degradation

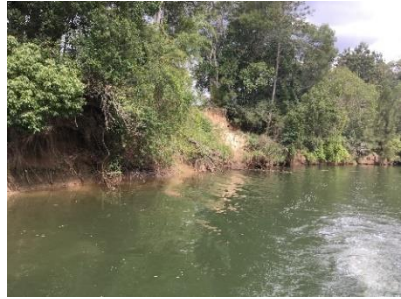
Site ID	Length (m)	Riparian Vegetation Condition	Bank Instability	Causes of Instability	Justification	Photo
1143	34	Poor	High	Natural meander	Significant degradation

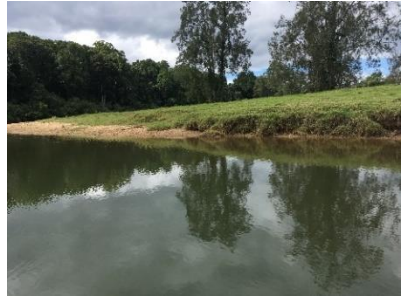
1146	432	Poor	Minor	Cattle access	Opportunity-easily accessible site which would benefit from low-cost works (stock exclusion fencing, revegetation and off stream water troughs).

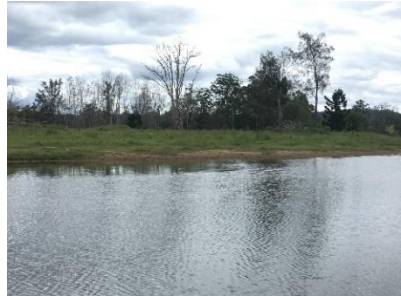
Site ID	Length (m)	Riparian Vegetation Condition	Bank Instability	Causes of Instability	Justification	Photo
1174	207	Poor	Insignificant	Cattle access	Opportunity- stock exclusion fencing, and riparian vegetation planting would significantly improve the site.

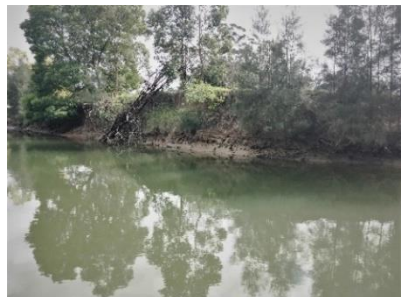
1094	193	Poor	High	Natural meander	Significant degradation

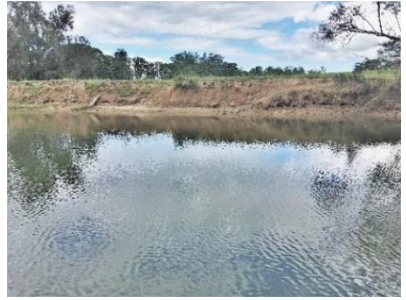
Site ID	Length (m)	Riparian Vegetation Condition	Bank Instability	Causes of Instability	Justification	Photo
1184	147	Poor	Moderate	Natural meander Cattle access	Opportunity- stock exclusion fencing and revegetation at this site would arrest erosion before it worsens.

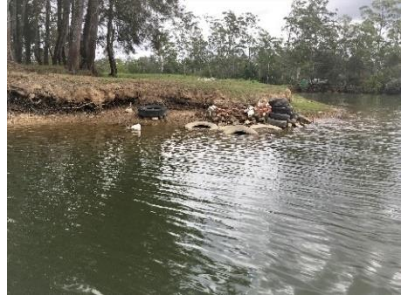
1187	231	Moderate	Moderate	Natural meander Cattle access	Opportunity- site would benefit from fencing and revegetating riparian zone and rubbish removal.

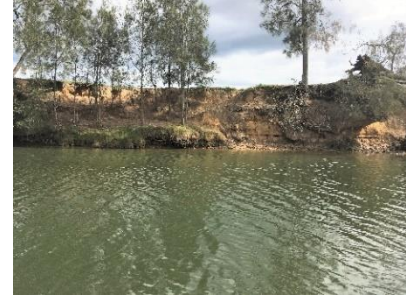
1194	34	Poor	High	Natural meander Cattle access	Significant degradation

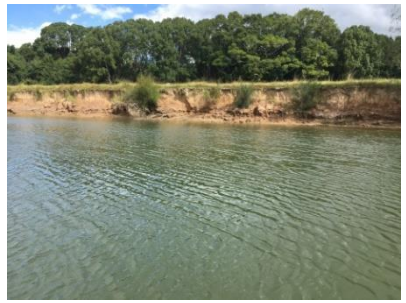
Site ID	Length (m)	Riparian Vegetation Condition	Bank Instability	Causes of Instability	Justification	Photo
1195	541	Poor	High	Natural meander Cattle access	Significant degradation

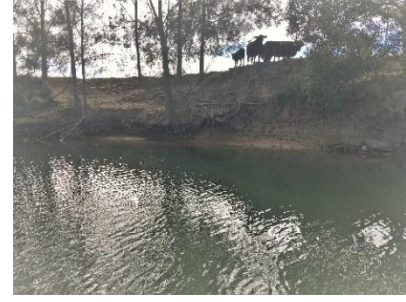
1065	118	Poor	High	Natural meander Cattle access	Significant degradation

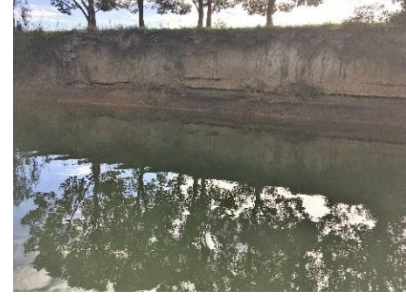
1066 & 1067	161 + 180	Poor	High	Not identified	Significant degradation

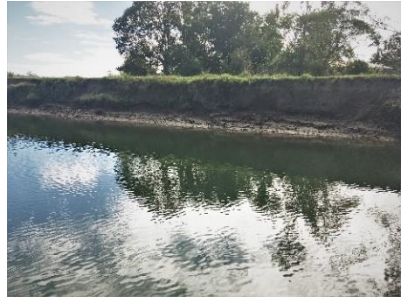
Site ID	Length (m)	Riparian Vegetation Condition	Bank Instability	Causes of Instability	Justification	Photo
1063	163	Poor	High	Natural meander Cattle access	Significant degradation

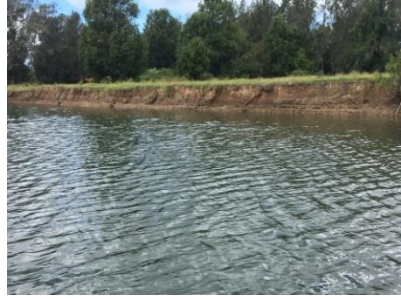
1206	285	Poor	High	Not recorded	Significant degradation

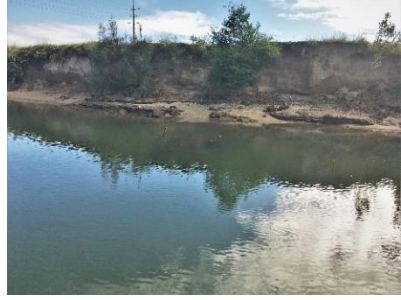
1046	241	Poor	High	Natural meander	Significant degradation

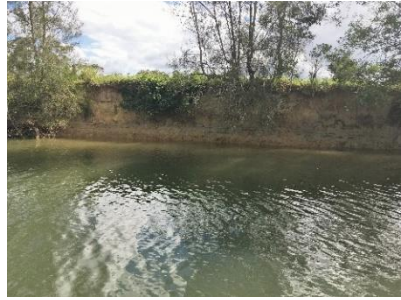
Site ID	Length (m)	Riparian Vegetation Condition	Bank Instability	Causes of Instability	Justification	Photo
1226	52	Poor	High	Natural meander	Significant degradation

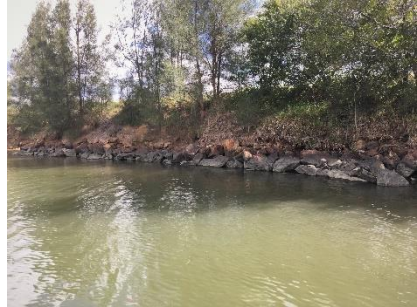
1228	25	Poor	High	Not recorded	Significant degradation

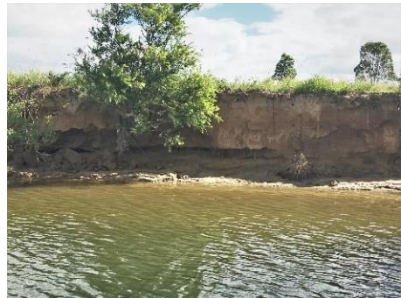
1234	201	Poor	High	Natural Meander Boat/wind waves	Significant degradation

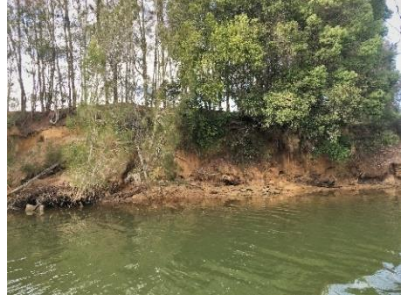
Site ID	Length (m)	Riparian Vegetation Condition	Bank Instability	Causes of Instability	Justification	Photo
1011	81	Poor	High	Natural meander	Significant degradation

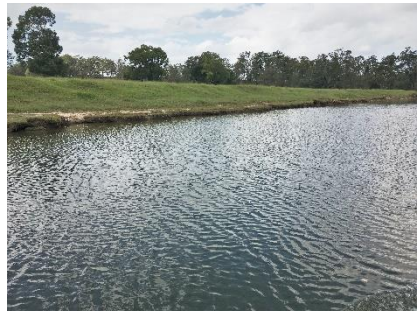
Site ID	Length (m)	Riparian Vegetation Condition	Bank Instability	Causes of Instability	Justification	Photo
760	123	Poor	Minor	Cattle access Boat/wind waves	Opportunity- grassy section of bank with cattle. Would benefit from stock exclusion fencing and revegetation.

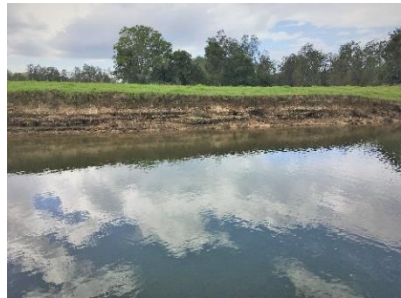
761	124	Poor	High	Natural meander Cattle access Wind/boat waves	Significant degradation

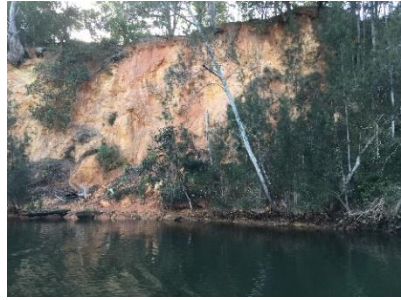
Site ID	Length (m)	Riparian Vegetation Condition	Bank Instability	Causes of Instability	Justification	Photo
617	20	Poor	High	Natural meander	Significant degradation

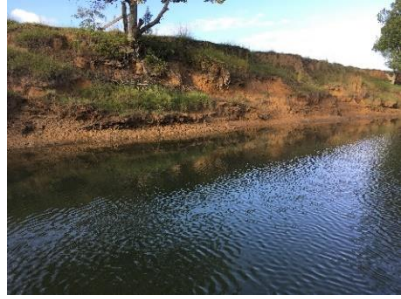
611	87	Poor	High	Natural meander	Significant degradation

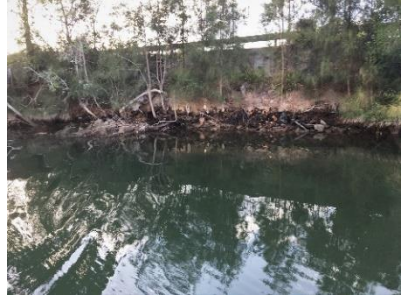
582	39	Poor	High	Natural meander Boat/wind waves	Significant degradation

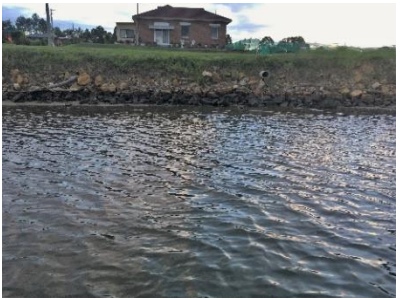
Site ID	Length (m)	Riparian Vegetation Condition	Bank Instability	Causes of Instability	Justification	Photo
905	36	Poor	Minor	Boat/wind waves	Opportunity- Grassy riparian zone in urban area would benefit from revegetation.

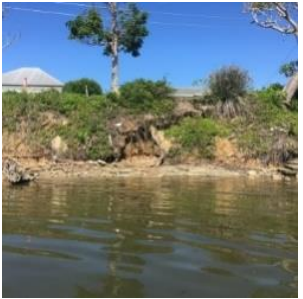
243	84	Poor	High	Not identified	Significant degradation

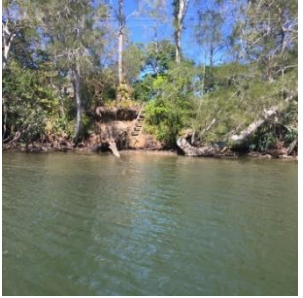
251	6	Poor	High	Structure Public access	Significant degradation

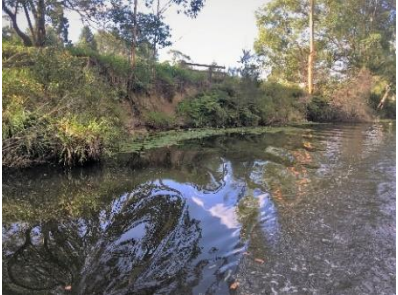
Site ID	Length (m)	Riparian Vegetation Condition	Bank Instability	Causes of Instability	Justification	Photo
419	70	Poor	High	Natural meander	Significant degradation

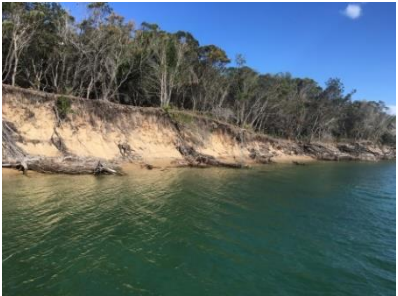
823	136	Poor	High	Natural meander	Significant degradation

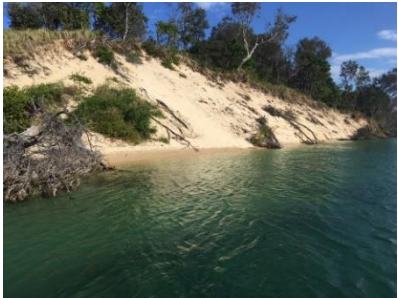
Site ID	Length (m)	Riparian Vegetation Condition	Bank Instability	Causes of Instability	Justification	Photo
819	103	Poor	High	Natural meander	Significant degradation

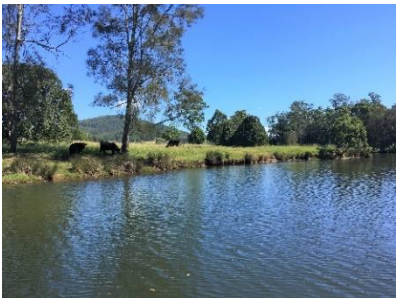
Site ID	Length (m)	Riparian Vegetation Condition	Bank Instability	Causes of Instability	Justification	Photo
90	489	Poor	Minor	Cattle access	Opportunity- Grassy banks with cattle. Site could be significantly improved with stock exclusion fencing and revegetation of banks.

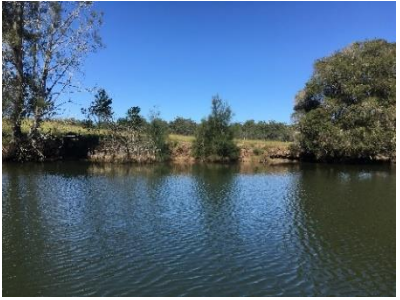
Site ID	Length (m)	Riparian Vegetation Condition	Bank Instability	Causes of Instability	Justification	Photo
169	462	Poor	Minor	Natural meander Cattle access	Opportunity- lack of vegetation on the banks, site could be significantly improved by revegetating the riparian zone.

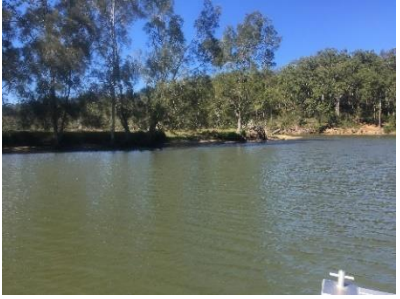
171	70	Poor	Insignificant	Cattle access	Opportunity- lack of vegetation on the banks and cattle access to water, site could be significantly improved by fencing and revegetating the riparian zone.

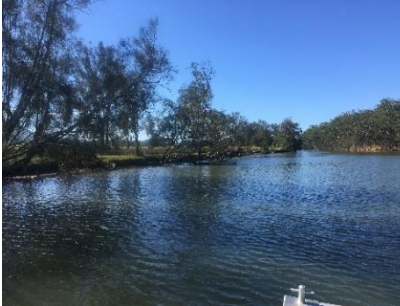
172	149	Poor	Minor	Natural meander Boat/ wind waves	Opportunity- site could be significantly improved by revegetating the riparian zone.

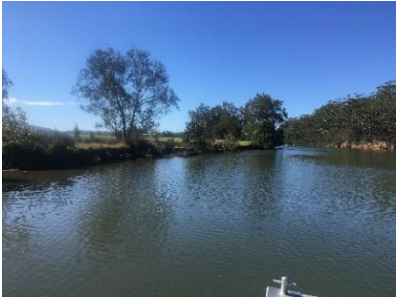
Site ID	Length (m)	Riparian Vegetation Condition	Bank Instability	Causes of Instability	Justification	Photo
174	103	Poor	Minor	Natural meander Boat/ wind waves	Opportunity- site could be significantly improved by revegetating the riparian zone.

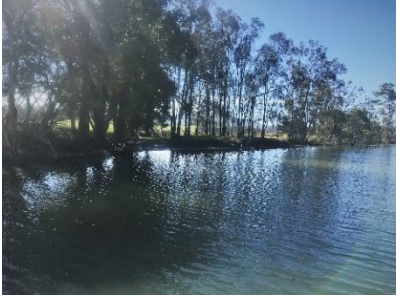
175	250	Poor	Minor	Natural meander Cattle access Boat/ wind waves	Opportunity- - site could be significantly improved by fencing and revegetating the riparian zone.
